Whitecross National School

14th November 2016

Report on Health & Safety visit to Whitecross National School Julianstown Co Meath by
MRSK Safety Consultants Ltd

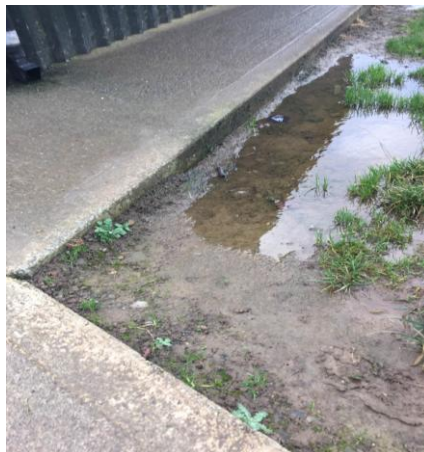
- There is an abundant of fall, trip hazards within the school yard ranging from severe uneven and cracked surfaces to footpaths proud of the surrounding grass verges. (See Photo)

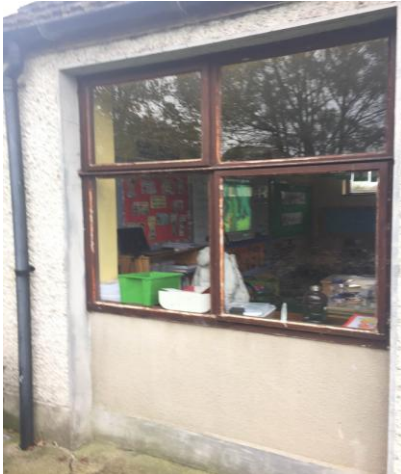
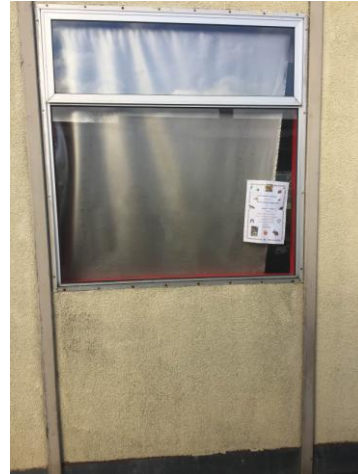
- The majority of windows in the school are original wooden framed single glazes giving very little or no insulation. It is alarming to see the amount of condensation on these windows which is not conducive to a healthy class room environment.

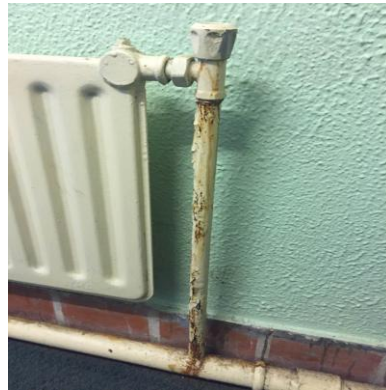
- Some of the window frames are rotten
- The heating system is original (single pipe gun barrel) and is inefficient with evidence of corroded piping throughout the building which needs to be addressed as a matter of urgency (See Photo)

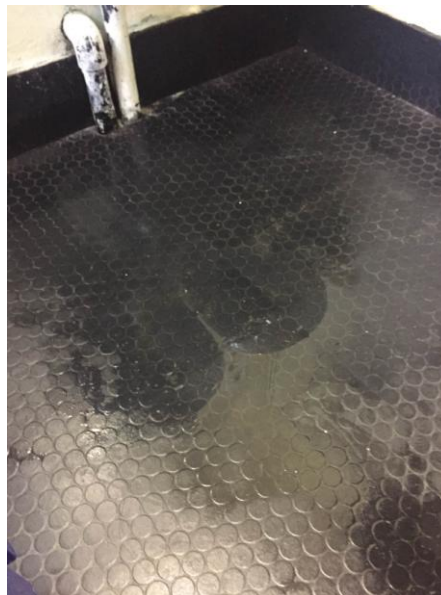
- There is evidence of substandard insulation throughout the building
- Toilet and washroom facilities are not sufficient for the number of children using them. There is evidence of leaking piping underneath the flooring. (See Photo)

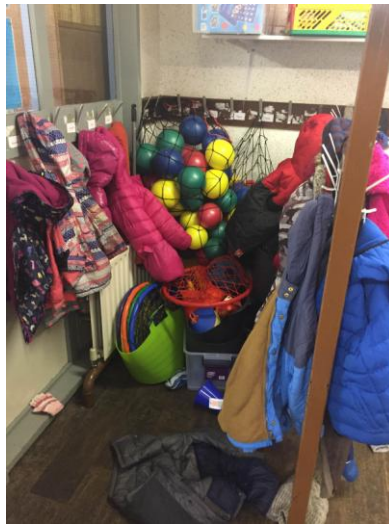
- The lack of storage space is evident through the school with cloakrooms and class rooms being used to store materials, this is a serious fire risk and trip hazard. (See Photo)

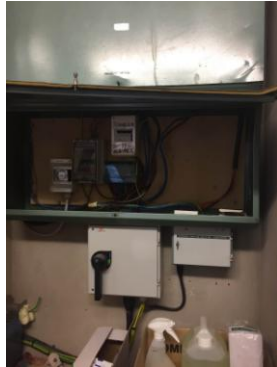
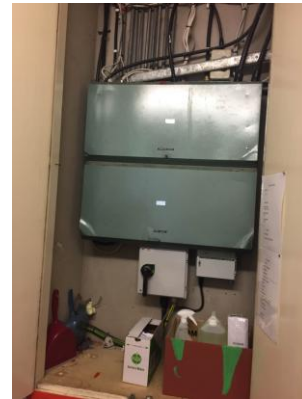
- The room where the electrical switch board for the school is situated is being used as a learning support room. The doors protecting the switch boards are made of ply wood with no fire rating, also the door and walls of this room have no fire rating whatsoever . (All electrical distribution boards should be enclosed in a fire resistant construction and any doors or access panels fitted will also require similar fire resistant panelling.)

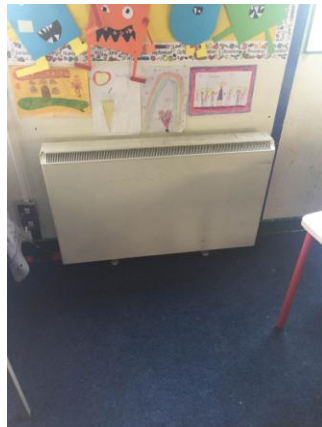
- There is inadequate Emergency lighting in the porta cabins. This lighting does not conform to current standards.
- There is evidence of leaking ceilings in some of the porta cabins
- The heating system is electric storage heating which is not efficient or cost effective. Some of the storage heaters have protective guarding around them and others do not thus endangering the children who come in contact with them.
- Children's work is displayed above some of the storage heaters this is a fire risk and endangers the children.
